Ultrasonic Nondestructive Evaluation of Pultruded Rod Stitched Efficient Unitized Structure (PRSEUS) During Large-Scale Load Testing and Rod Push-Out Testing

*Patrick H. Johnston and Peter D. Juarez
Langley Research Center, Hampton, Virginia 23681*

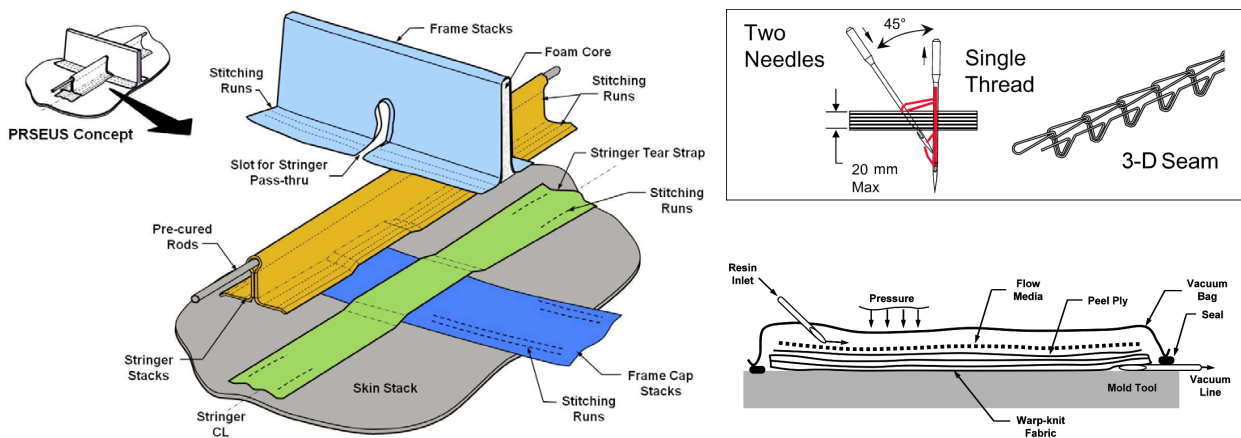
FIGURE 1. The PRSEUS dry preform is built up from carbon fabric stacks for the frame, stringers and skin. The layers are stitched together with Vectran fibers, using a single-sided sewing method, then bagged and infused with resin [10].

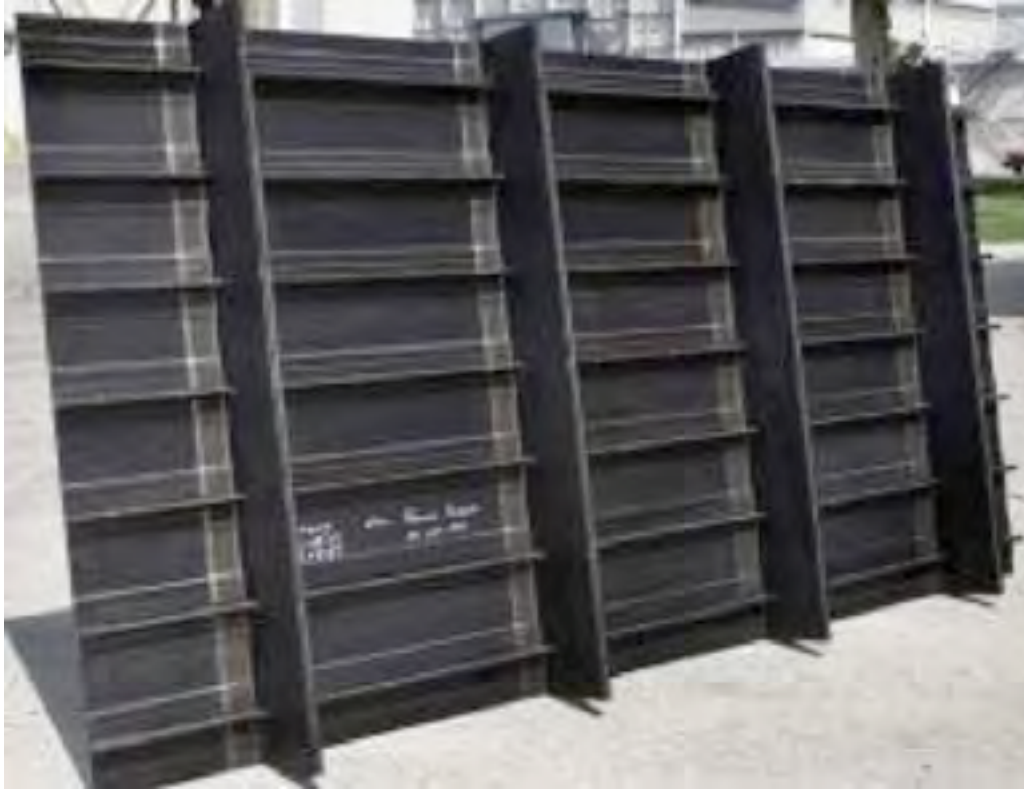
Figure 2. An example of a PRSEUS panel. This particular flat panel comprises four frames and seven stringers [10].

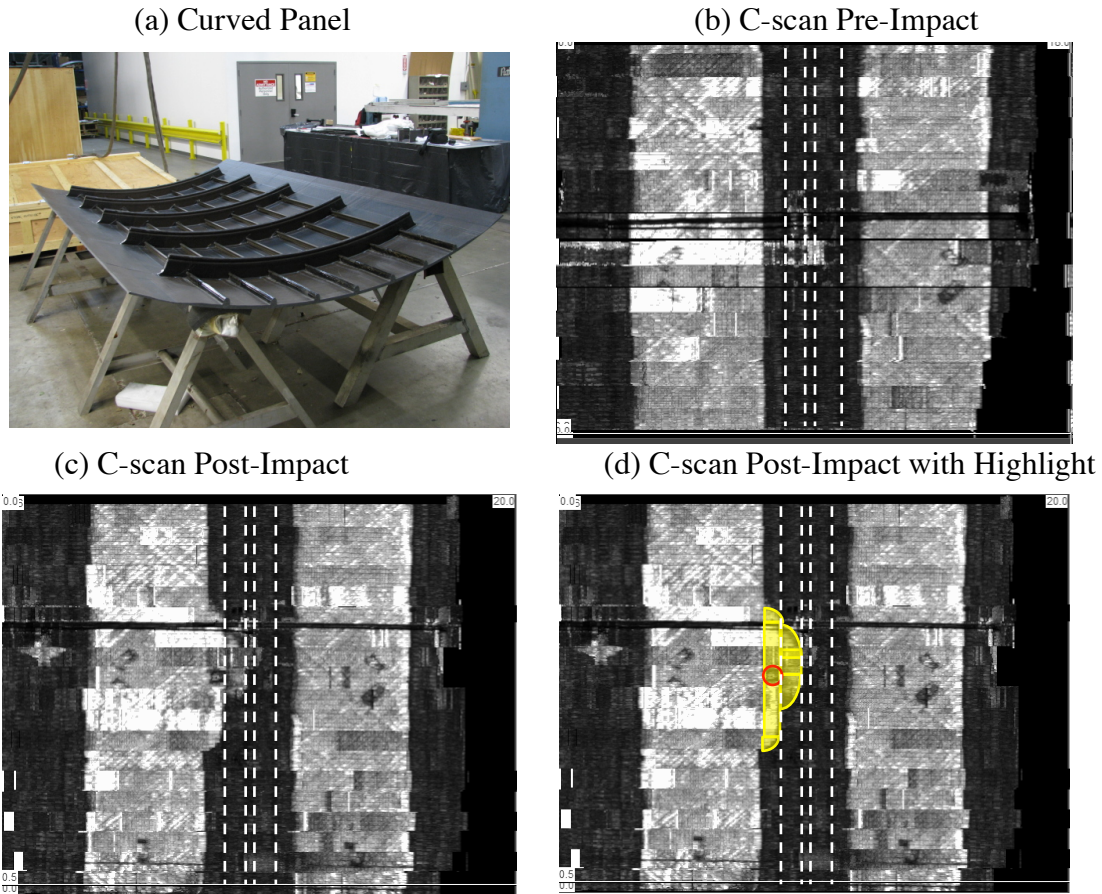
FIGURE 7. (a) Photograph of the curved test panel. (b) C-scan (18"x20") of panel before BVID. Rectangular indication at center is a signal artifact due to coupling. (c) C-scan of panel after BVID. (d) Post-impact C-scan with a cartoon outline to highlight the delamination and the impact point (circle).

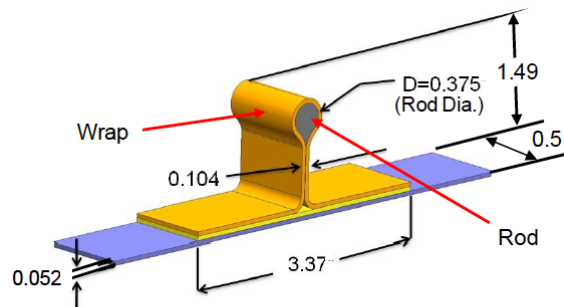
FIGURE 10. Drawing of a typical rod push-out specimen.

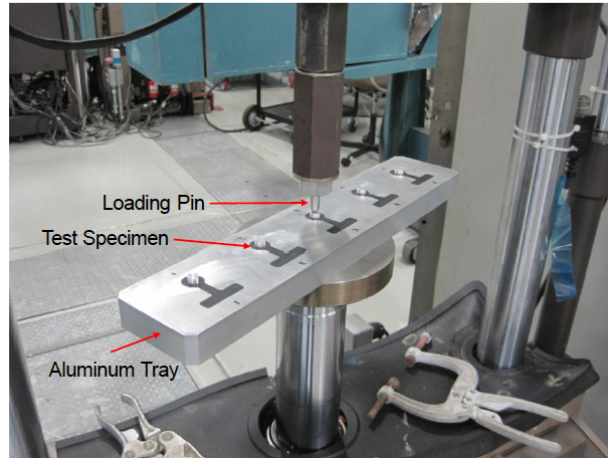
FIGURE 11. Photo of the rod push-out test apparatus.

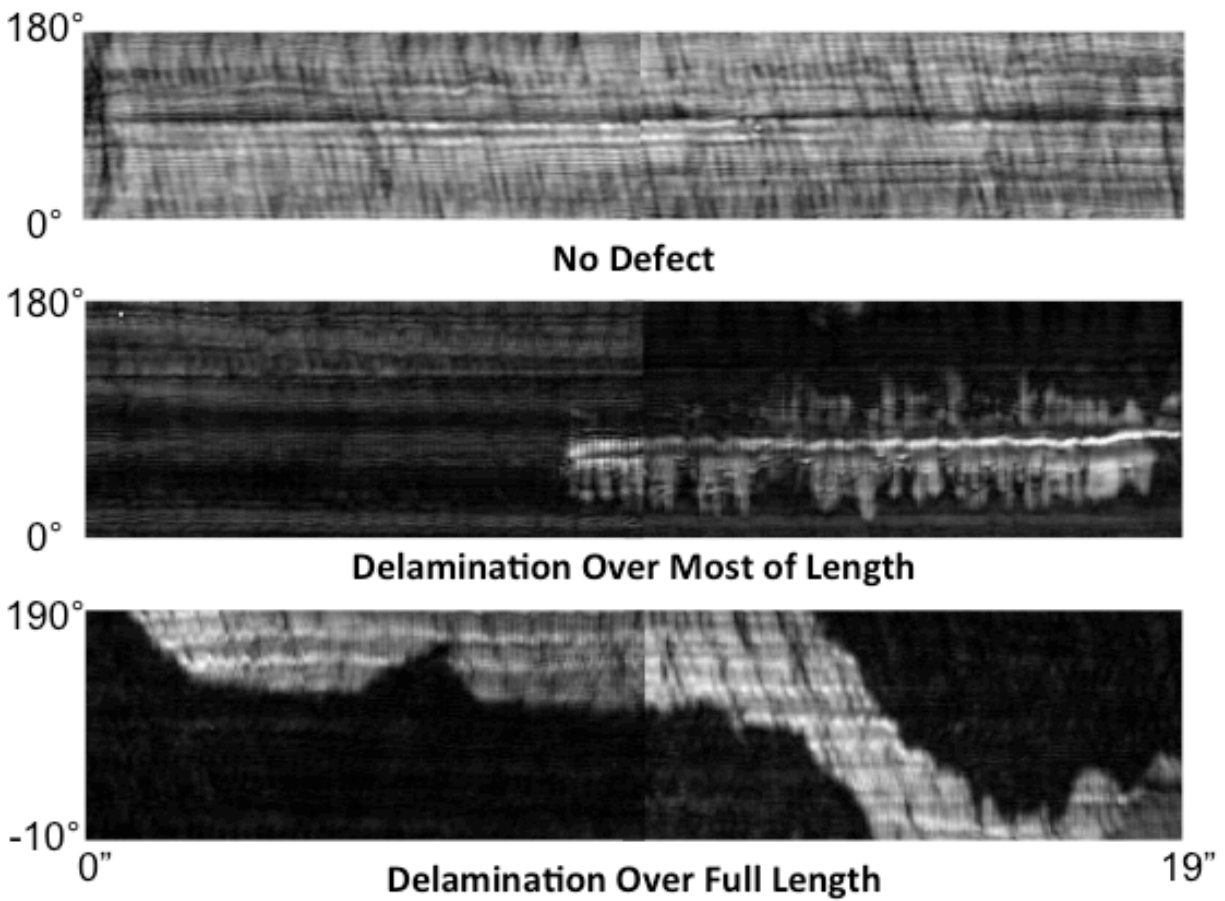
FIGURE 12. Ultrasonic pulse-echo C-scans of three rod specimens prior to cutting into push-out specimens. In the upper scan, the ultrasonic response is relatively uniform, having only normal textural variations resulting from the fabric overwrap. In the center and lower scans, debonds between the overwrap and rod produce echoes much larger than the normal background.

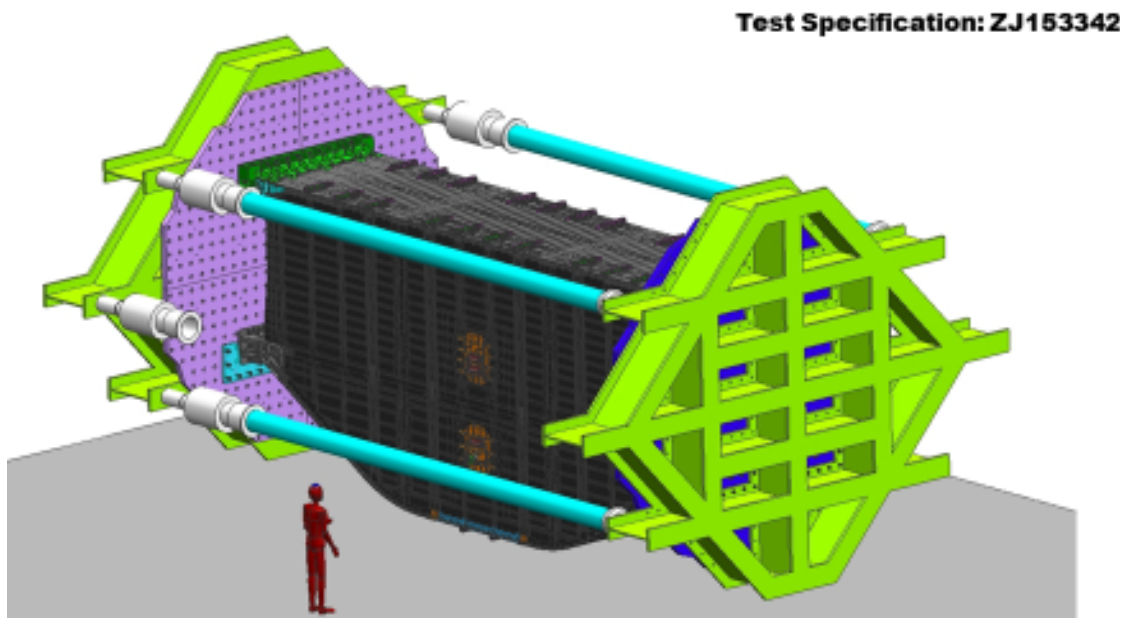
FIGURE 14. Drawing of the Combined Loads Test Systems (CoLTS) with the Multi-Bay Box installed between the loading platens.

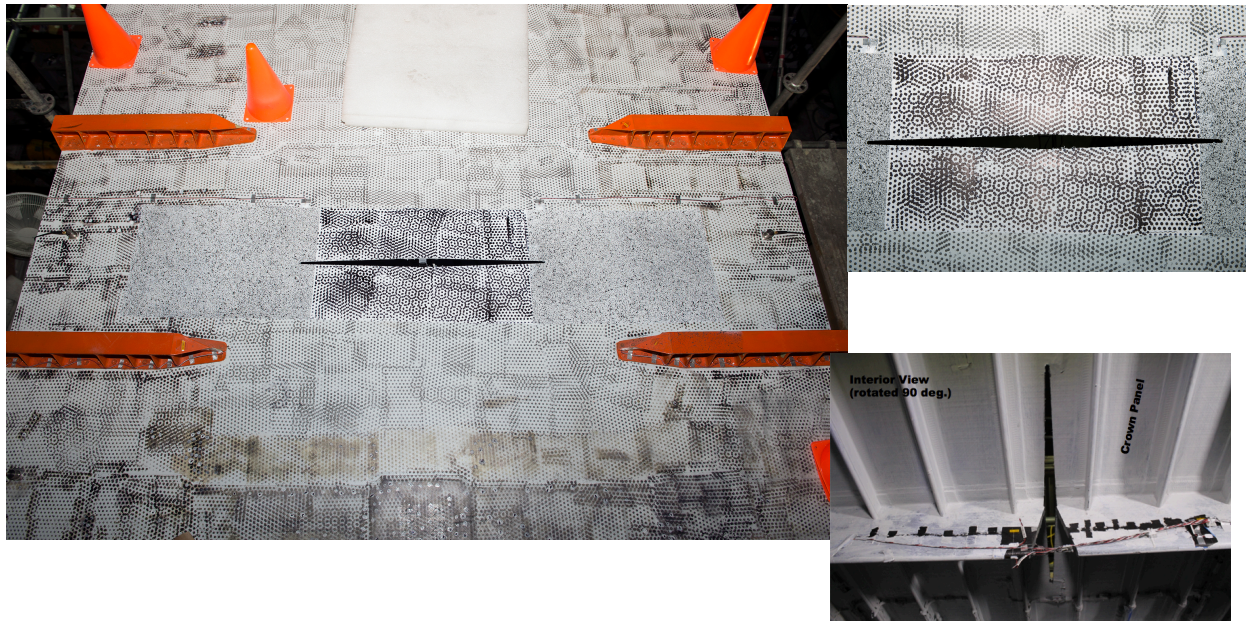
FIGURE 15. Saw cut on the crown of the MBB to initiate final failure event.

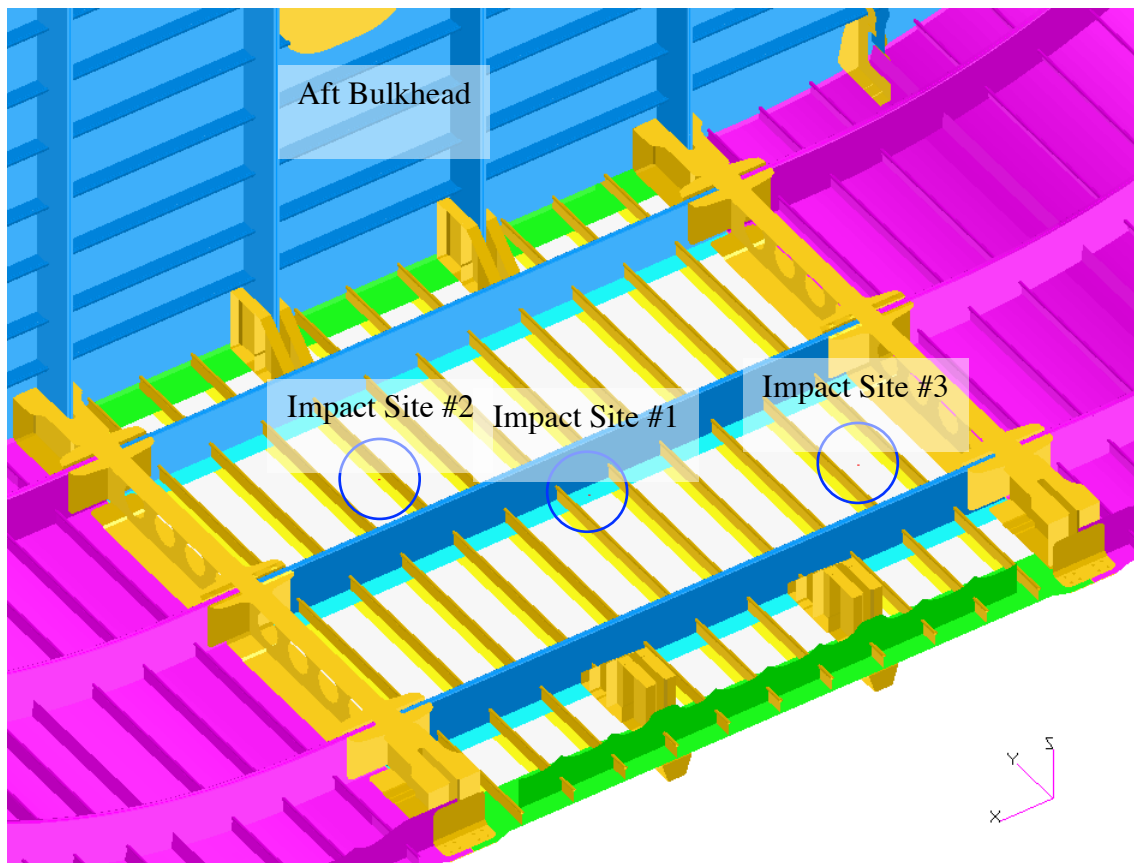
FIGURE 16. Locations of the three impact sites on the center keel of the test article.

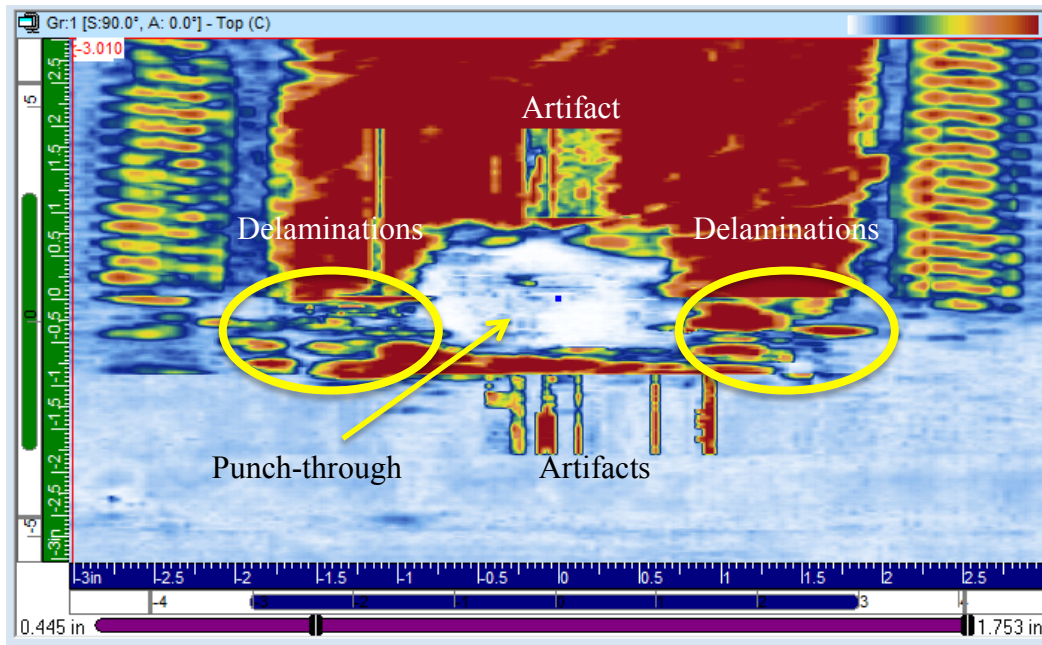
FIGURE 23. Ultrasonic data of the delamination damage caused by the center frame keel impact. Note that the artifacts in this image are a result of strain gage placement which cause an issue in coupling with scanning probe.

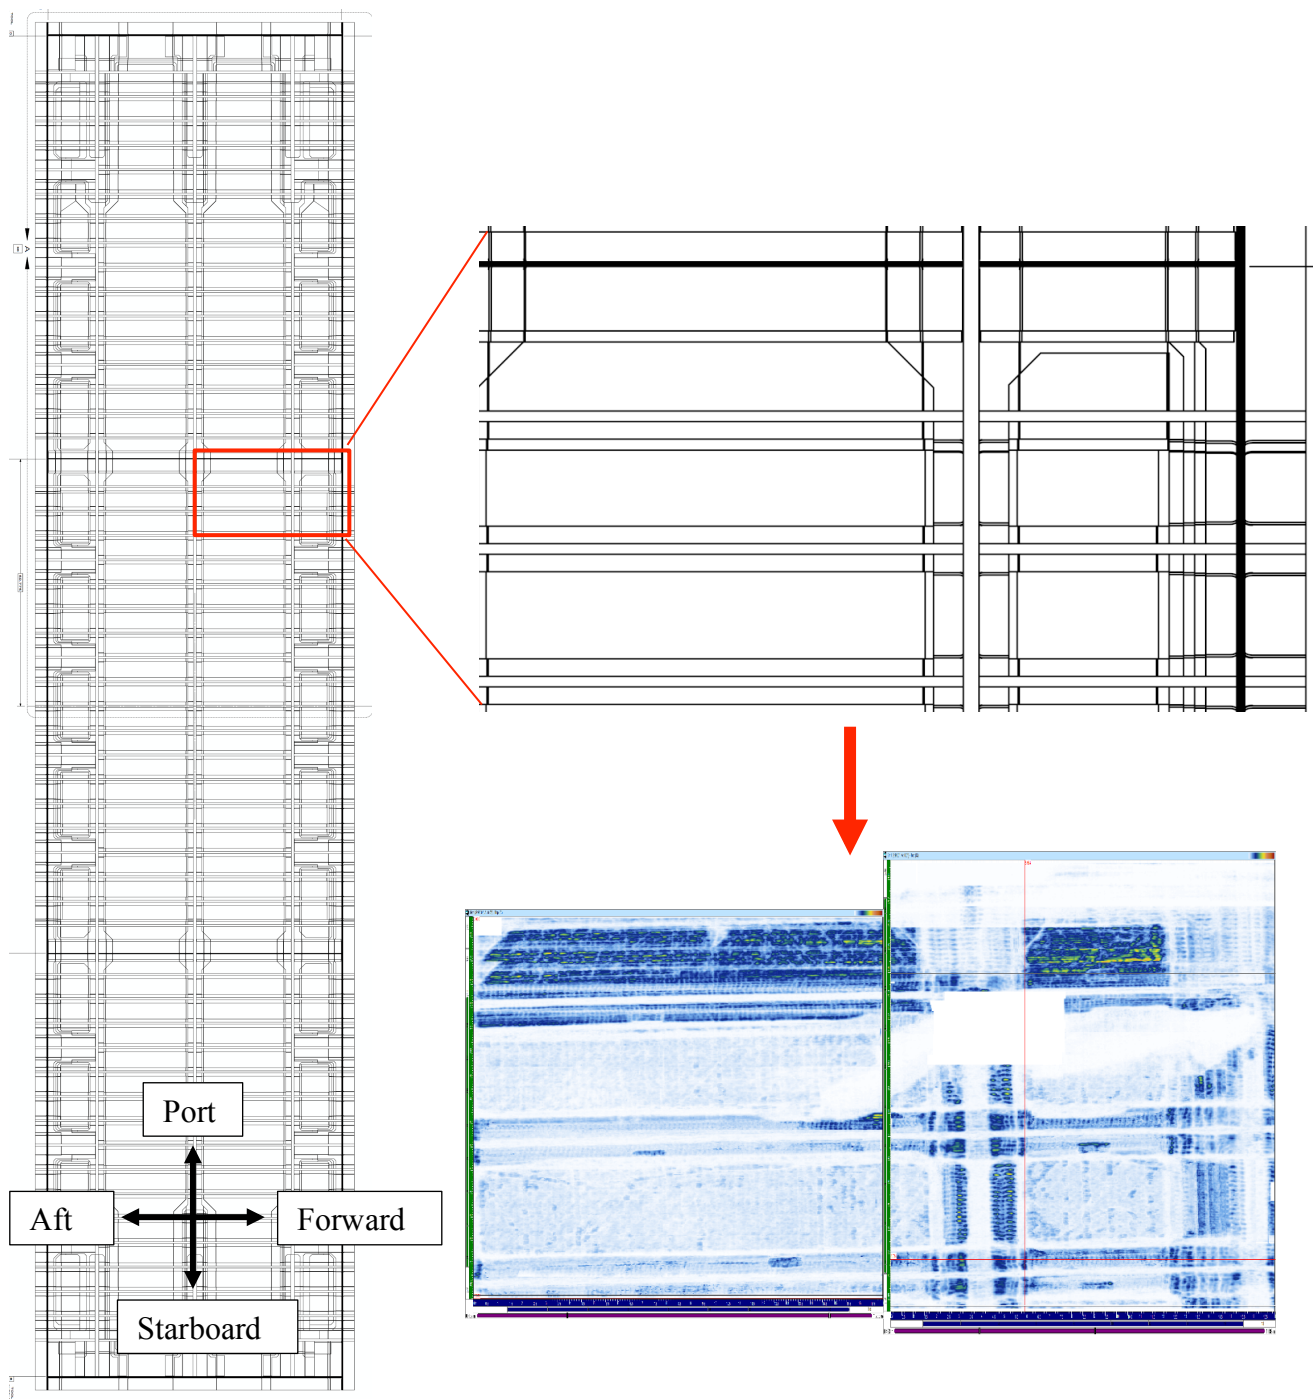
FIGURE 27. The location of the scans performed on the portside forward edge of the crown.

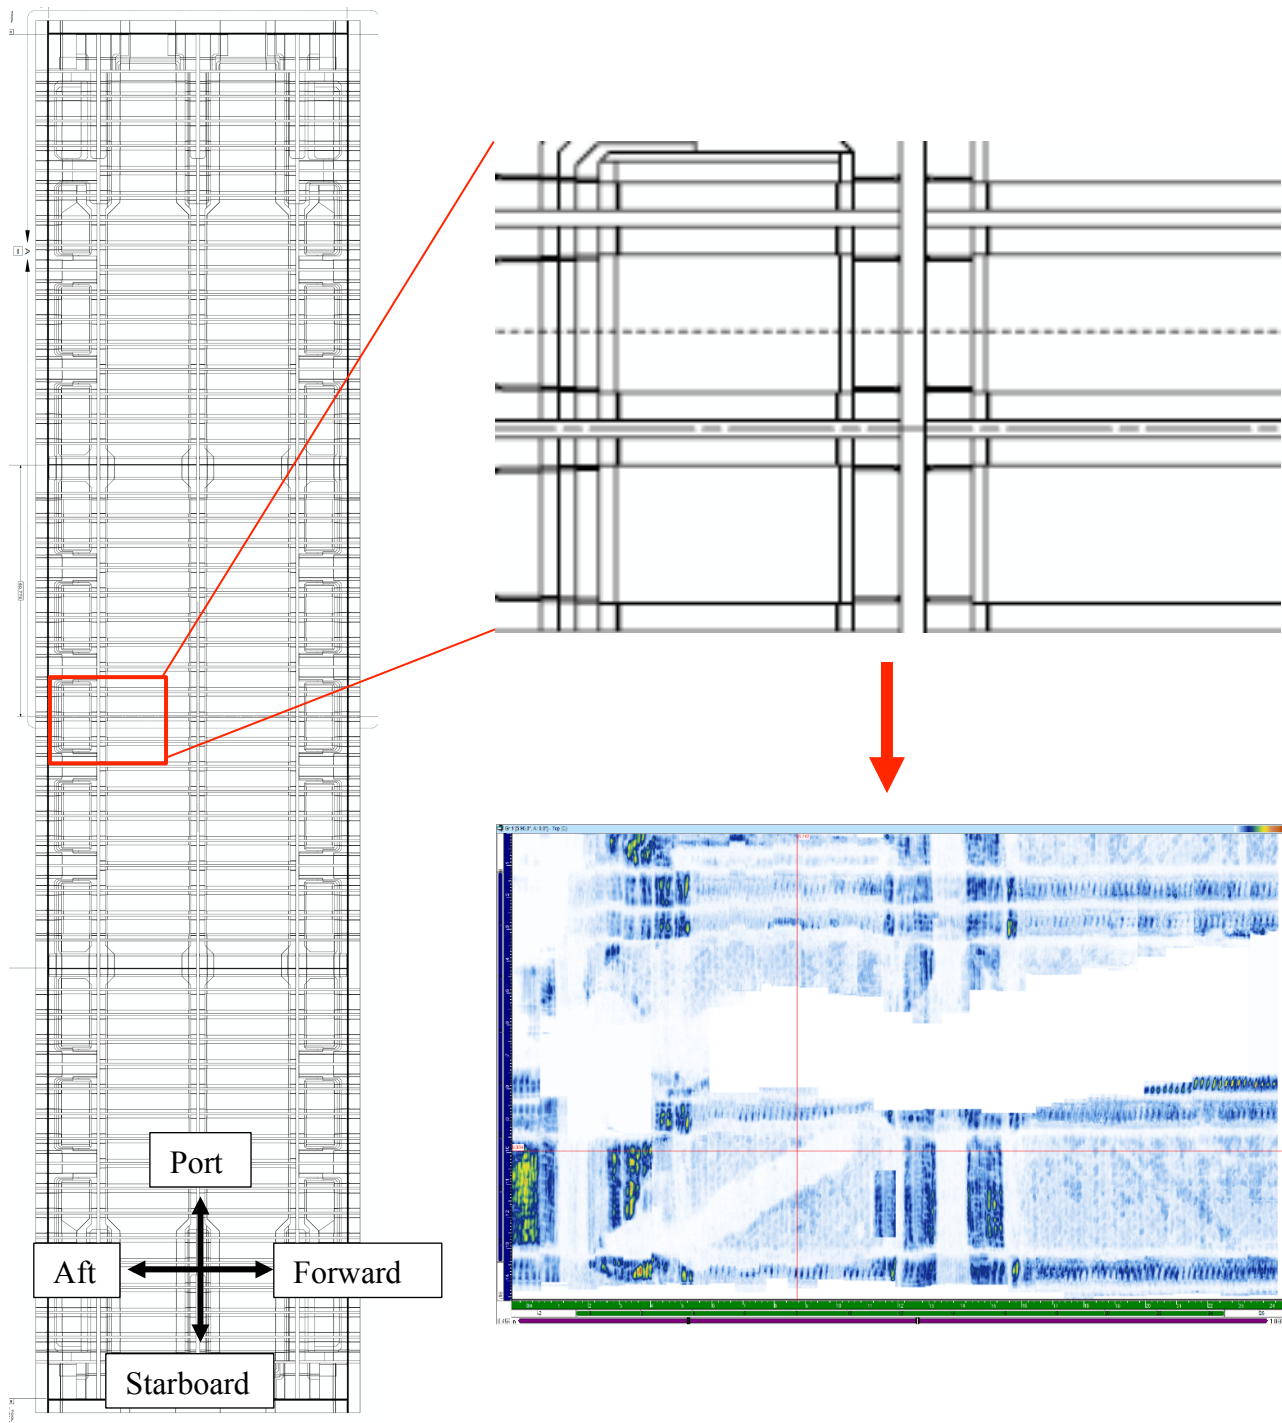
FIGURE 32. The location of the scan performed on the aft side of the saw cut.

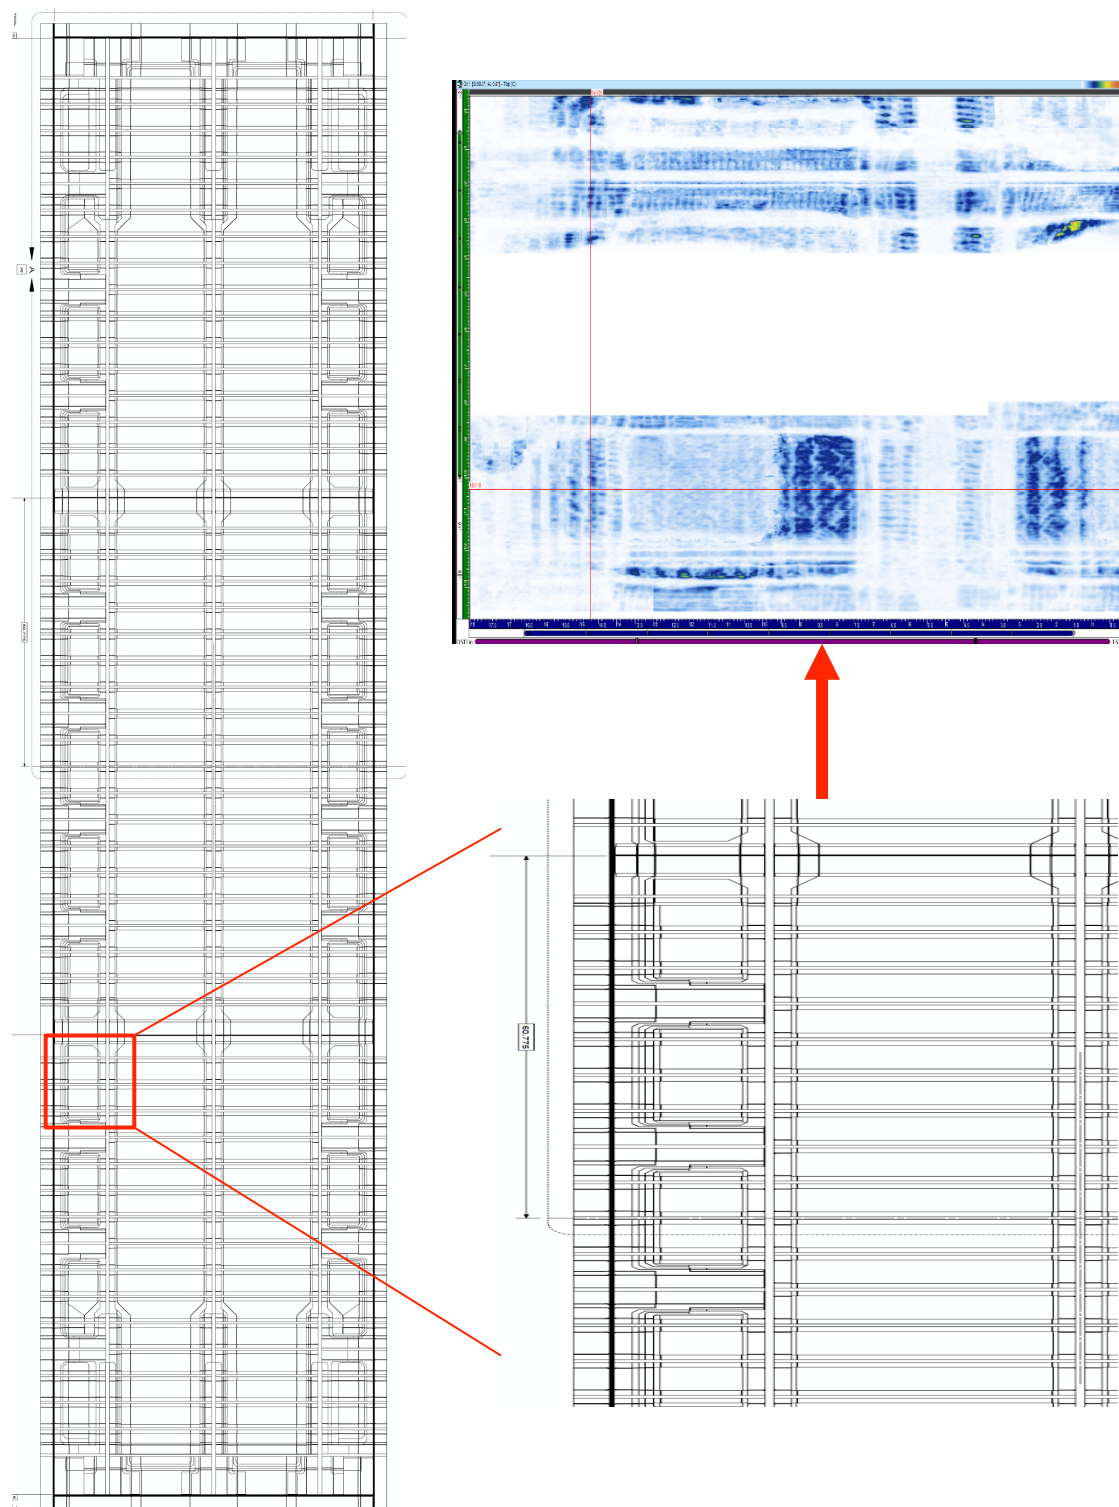
FIGURE 34. The location of the aft edge scan of the starboard failure crack.

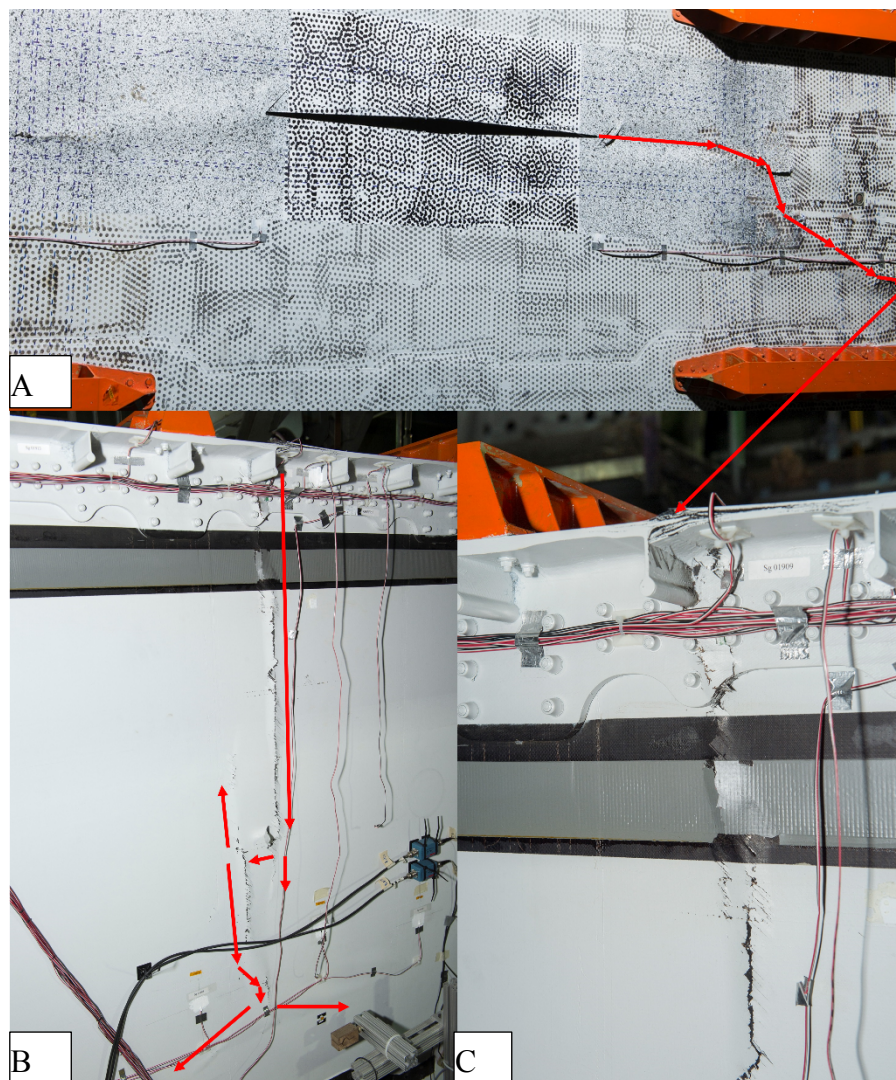
FIGURE 36. Photos of the failure crack that started from the forward side of the crown and extends into the forward bulkhead.

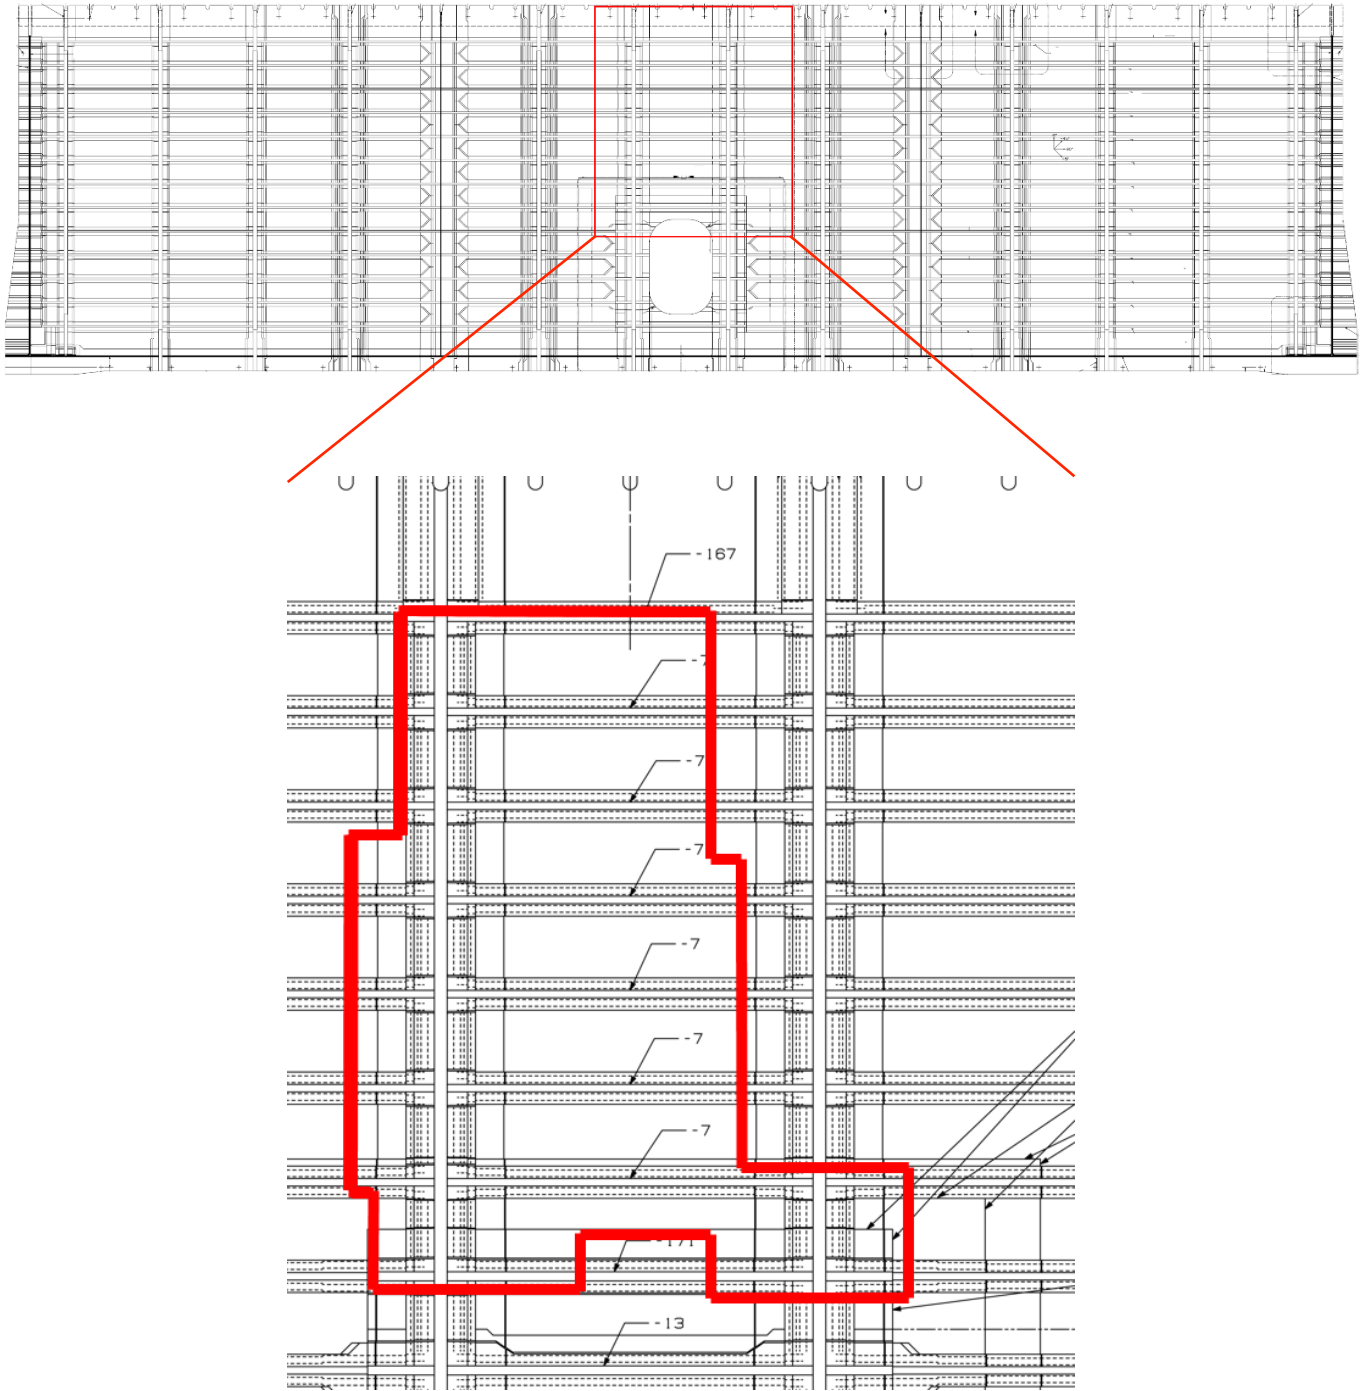
FIGURE 37. The location of the six forward bulkhead scans

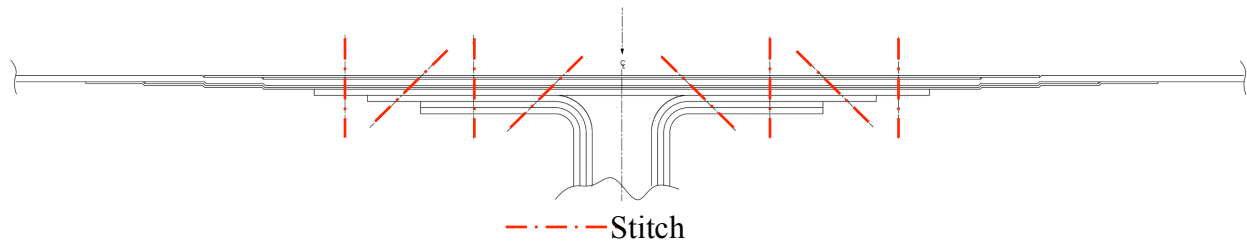
FIGURE 40. Detailed image of the cross section of a frame build up, showing the different stitch incident angles.

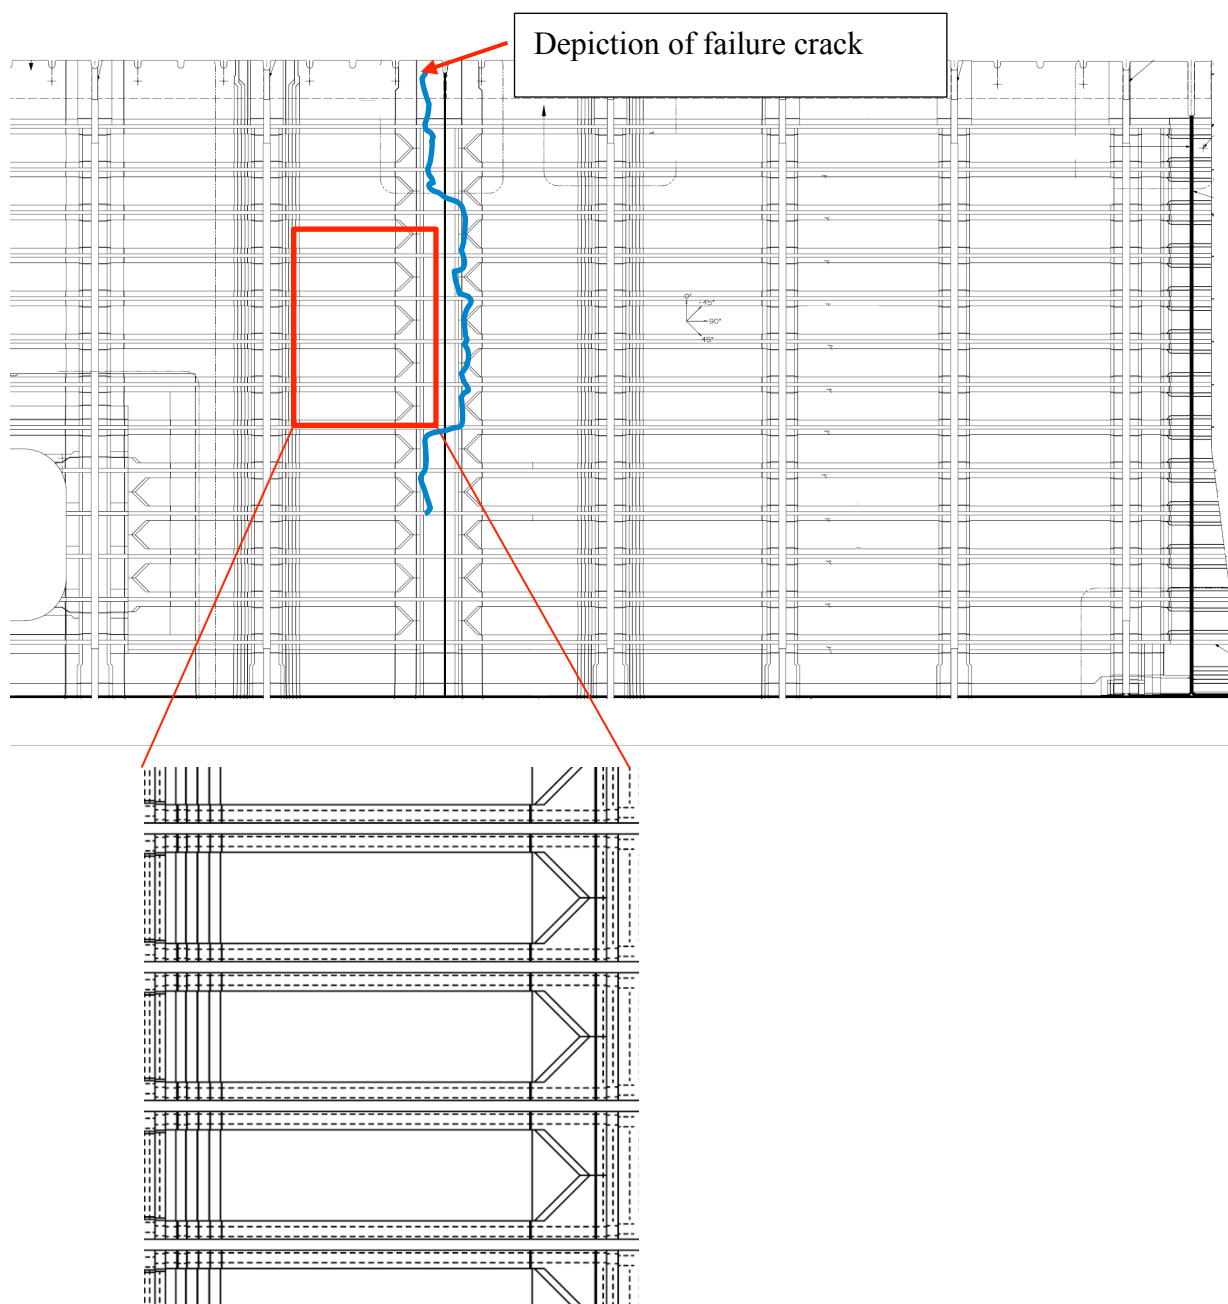
FIGURE 46. Location of the aft bulkhead failure crack in relation to the structure geometry.

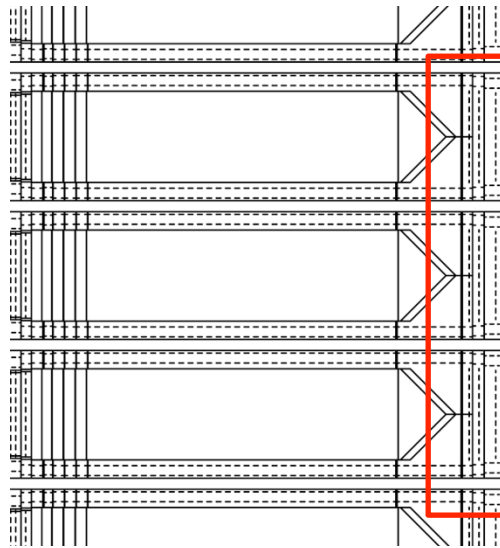
FIGURE 48. Location of the second scan area on the aft bulkhead.

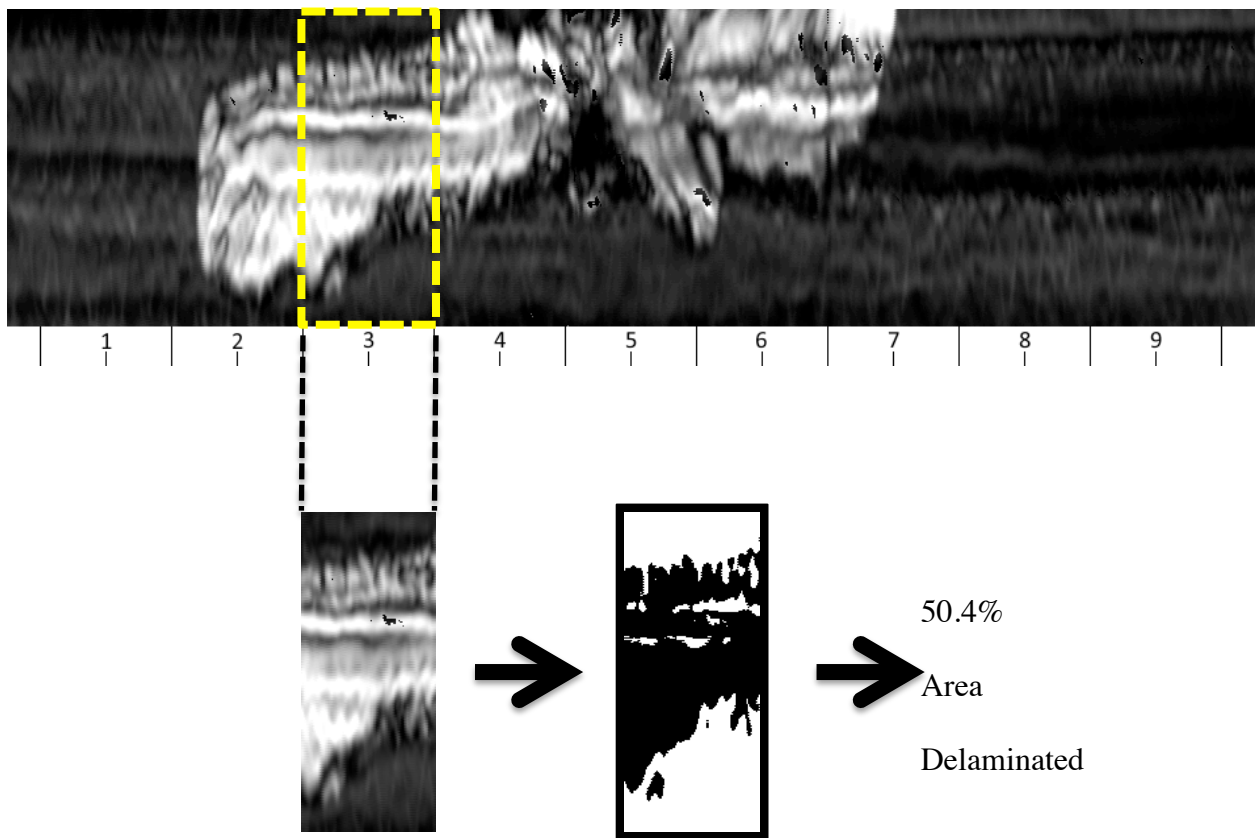
FIGURE 51. Example of the calculation of fractional area of delamination in a push-out specimen.
